Original Article

Evaluation of Groundwater Quality in Peri-urban Community of Malete, North-Central, Nigeria

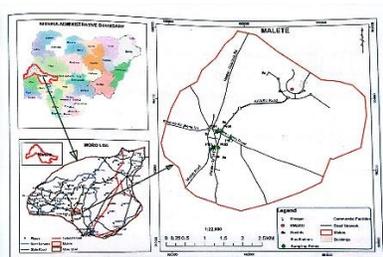
Figure 1: Map of the Study Area Showing Sampling Points

Gate, and Tarmac (Figure 2a - e). The wells were designated as Well 1 to Well 5 (Table 1) and Global Positioning System (GPS) was used to collect coordinates for production of the study area map (Figure 1). From each well, 2 L of water were collected using sterilized water samplers. Samples were properly labelled, stored in ice-cooled boxes, and transported to the laboratory for analysis within 24 hours of collection. On-site measurements of temperature, pH, and electrical conductivity were performed using standard methods described by APHA [17]. Temperature was measured with a calibrated mercury thermometer, pH was

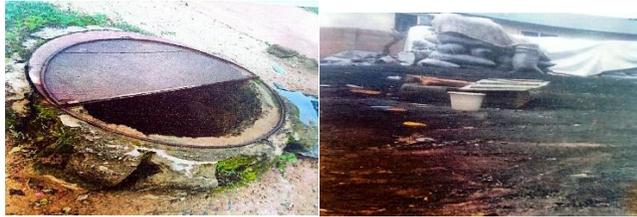
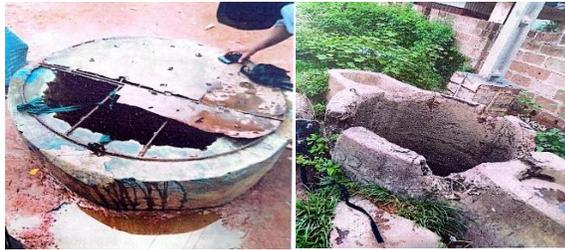
Figure 2a-e: Pictures of Hand dug wells at (a) Safari, (b) Malete Market, (c) Tarmac, (d) KWASU Gate, (e) Westend

Location	Coordinates	Well Identification	Well Description
Safari	8.70172 N 4.46832 E	Well 1	<ul style="list-style-type: none"> ■ Covered with metallic slab and under lock ■ Surroundings tidy ■ 5m from pit latrine ■ Inside lined with cement ■ Used for domestic purpose ■ Multiple receptacles used
Market	8.7110434N 4.4634610E	Well 2	<ul style="list-style-type: none"> ■ Surroundings not tidy ■ Inside lined with cement ■ Multiple receptacles used ■ Used for domestic purposes ■ Sited close to charcoal production site
Tarmac	8.7100173N, 4.4667263E	Well 3	<ul style="list-style-type: none"> ■ Covered with rusty metallic slab that is mostly left opened ■ Surroundings tidy ■ Inside lined with concrete ■ Multiple receptacles used ■ Used for domestic and other purposes
School gate	8.715977N 4.470007E	Well 4	<ul style="list-style-type: none"> ■ Uncovered ■ Surroundings untidy ■ Inside lined with cement ■ Multiple receptacles used ■ Used for domestic purposes ■ Close to refuse dumps

Westend	8.7036860N 4.4694534E	Well 5	<ul style="list-style-type: none"> ■ Covered with metallic slab ■ Surroundings untidy ■ Inside lined with concrete ■ Used for domestic purposes ■ Multiple receptacles being used

Water samples were collected from five (5) perennial hand-dug wells used for communal purposes across five locations in Maleté: Westend, Safari, Market, School
