Morphological Characteristics and Soil Physical Attributes of Erhumunse Gully in Benin-City, Edo State: Implications for Household Crop Cultivation

Adegun O., Eremen P.E. & Odunuga S.
Department of Geography, University of Lagos, Lagos

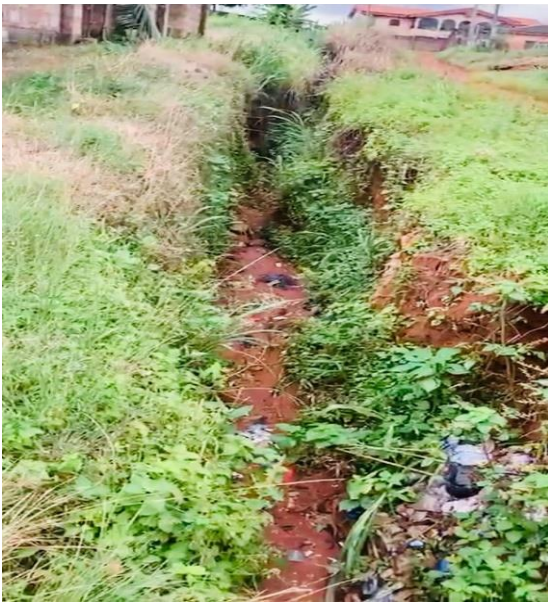
Figure 2: (a) Gully site
Source: Authors (2024)

The results of the analysis of the morphological characteristics of Erhumwunse gully based on Suresh's (2006) classification scheme are presented in Table 2. As shown in Table 2, the Erhumwunse gully is in its second stage of development. It is a medium, U-shaped active gully with a depth of 5 m and a width of 7 m.

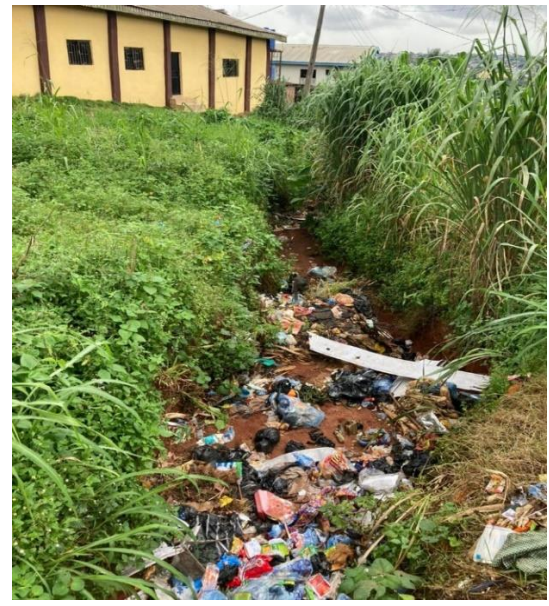
Figure 2: (b) Gully converted to dumpsite
Source: Authors (2024)

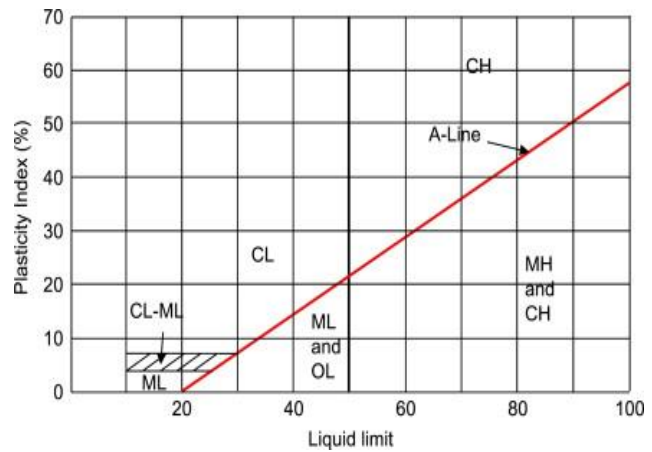
Figure 4: Unified Soil Classification System

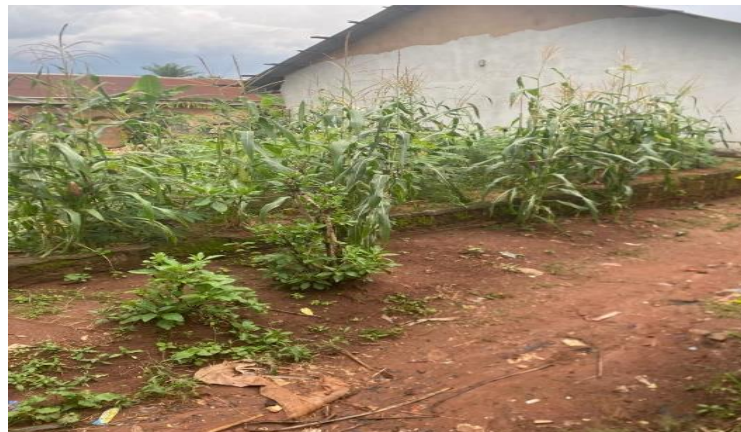
Figure 6: Demarcation to Safeguard a Home Garden from the Impact of Gully Erosion.
