The October 13, 2010 Landslides on The Azenge Mountain in Imande Ukusu, Nkomon District, Kwande Local Government area, Benue State, Nigeria

Ako Thomas Agbor, Abba Francis Mohammed, Onoduku usman Shehu, Nuhu Waziri
Musa, Alabi Adekola A. and Mamodu Adegbe

Department of Geology, School of Natural and Applied Sciences, Federal University of
Technology, Minna, Nigeria.
E-mail: akoagbor@futminna.edu.ng

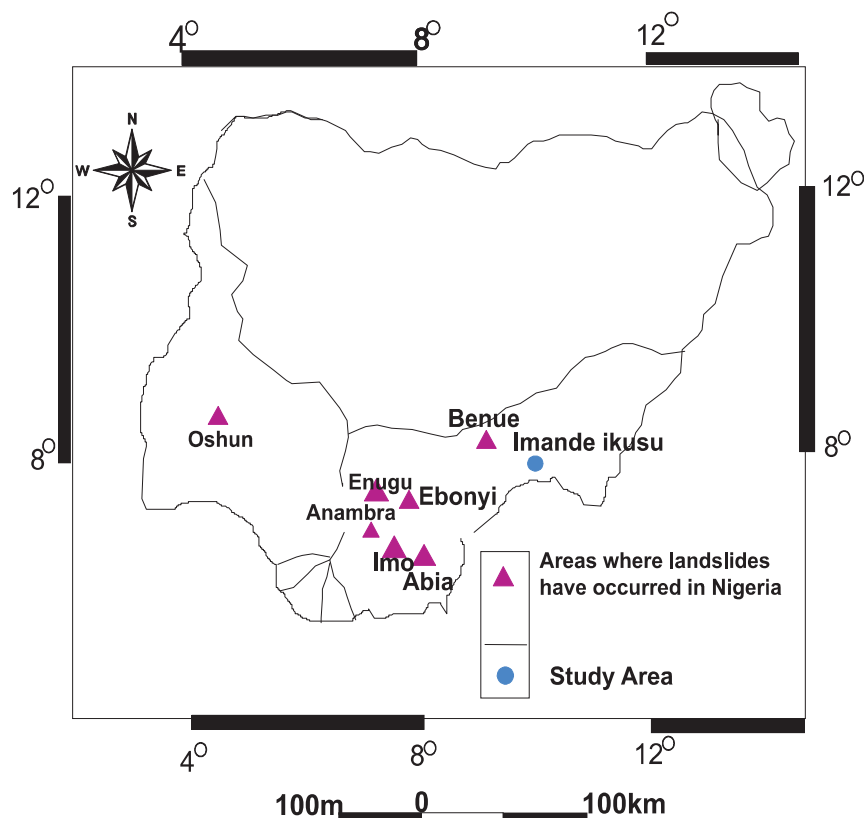
Figure 1: Map of Nigeria showing areas where landslides have occurred (adopted from Igbokwe et al., 2008).

Several landslides have occurred in Nigeria but many of them are not recorded except when people are killed and/or a good number of properties are destroyed. Literature on landslides in Nigeria is limited to short reports from the Nigeria Geological Survey Agency (NGSA), Ministry of Environment, internet and eye-witness reports that simply make mention of the disaster and casualties (Igbokwe et al., 2008). No thorough investigation regarding the triggering mechanism and extent and nature of the landslides is usually carried out. Description of the various possible causes of the landslides, nature of the rock types and weathered materials affected are also not always reported. Most of the occurrences are not reported due to negligence and lack of appreciation of this natural phenomenon at both States and Federal levels. Landslides have occurred over the time in some parts of Nigeria destroying lives and properties such as in Osun, Benue, Enugu, Abia, Anambra, Ebonyi and Imo States (fig. 1).

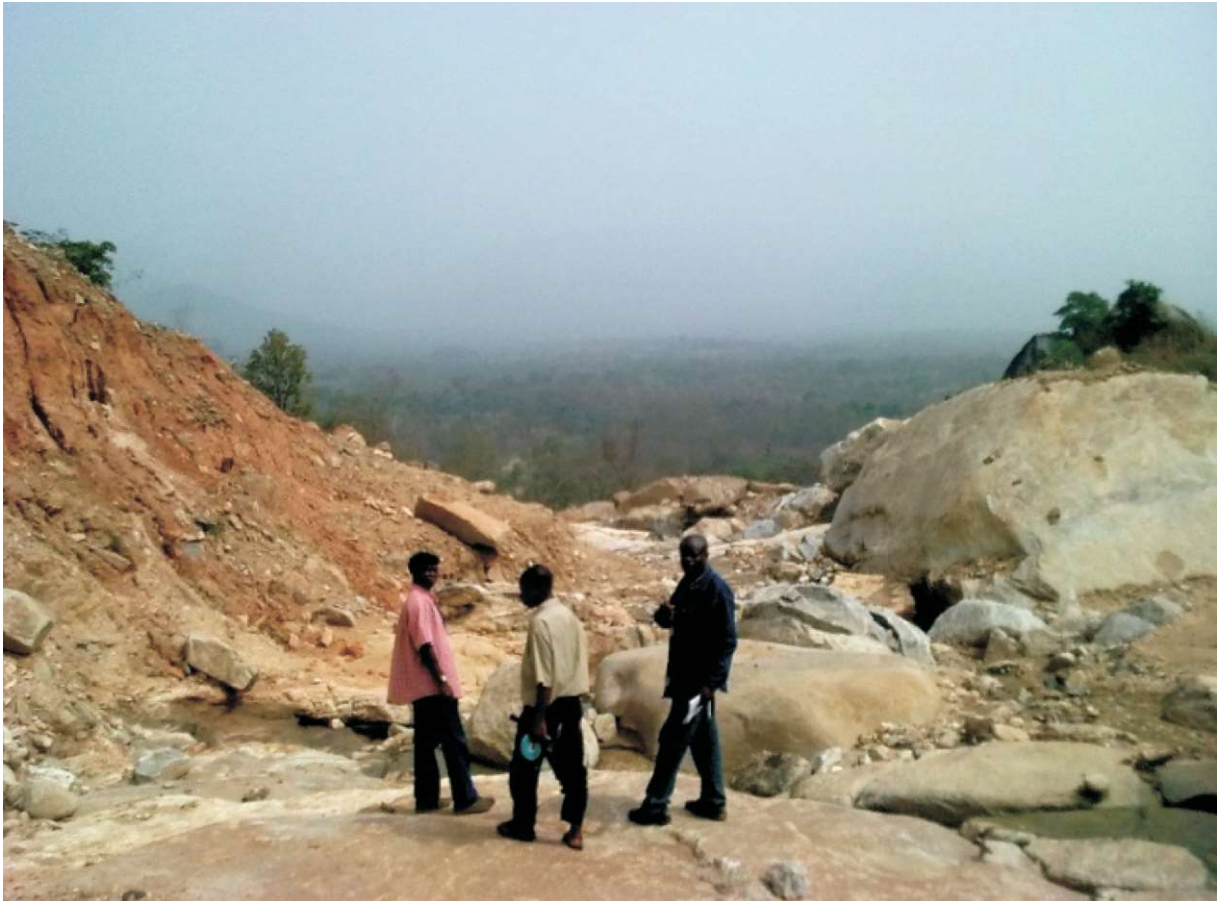
Plate 1: Photograph of major landslide out of the fourteen that occurred in the area

district. A total of fourteen landslides occurred along the huge mountain range surrounding the area but only the one that caused most damage to the area was studied (plate 1). According to him, only one person lost his life. He must have been killed by the remaining large boulders that were sliding towards the toe of the hill on his way to the farm around 5 am. No buildings were affected because human settlements were located away from the area where the landslide occurred.

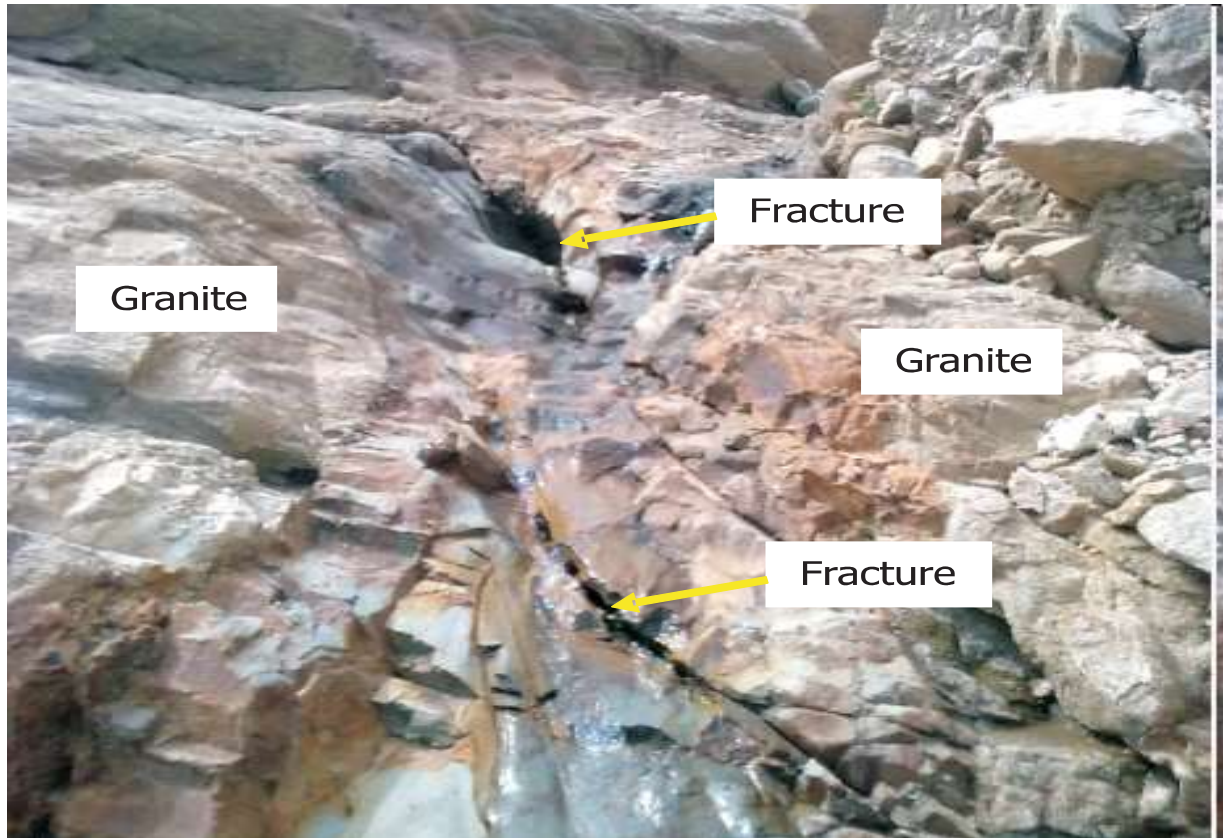
Plate 2: Photograph of fractures that permit water to percolate and cause weathering and weakness of the rock unit

The presence of too many fractures on both the rocks that were moved and those in the adjoining area suggests fractures in the rock provided passage for weathering fluids (Plate 2). Fractures in the rocks acts as common translational slip planes. The presence of some clay minerals along some fracture zones in the rocks supports the view that the landslides occurred as a result of absorption of water by these clay minerals (Ayonghe et al., 2004 and Plummer, 2003).

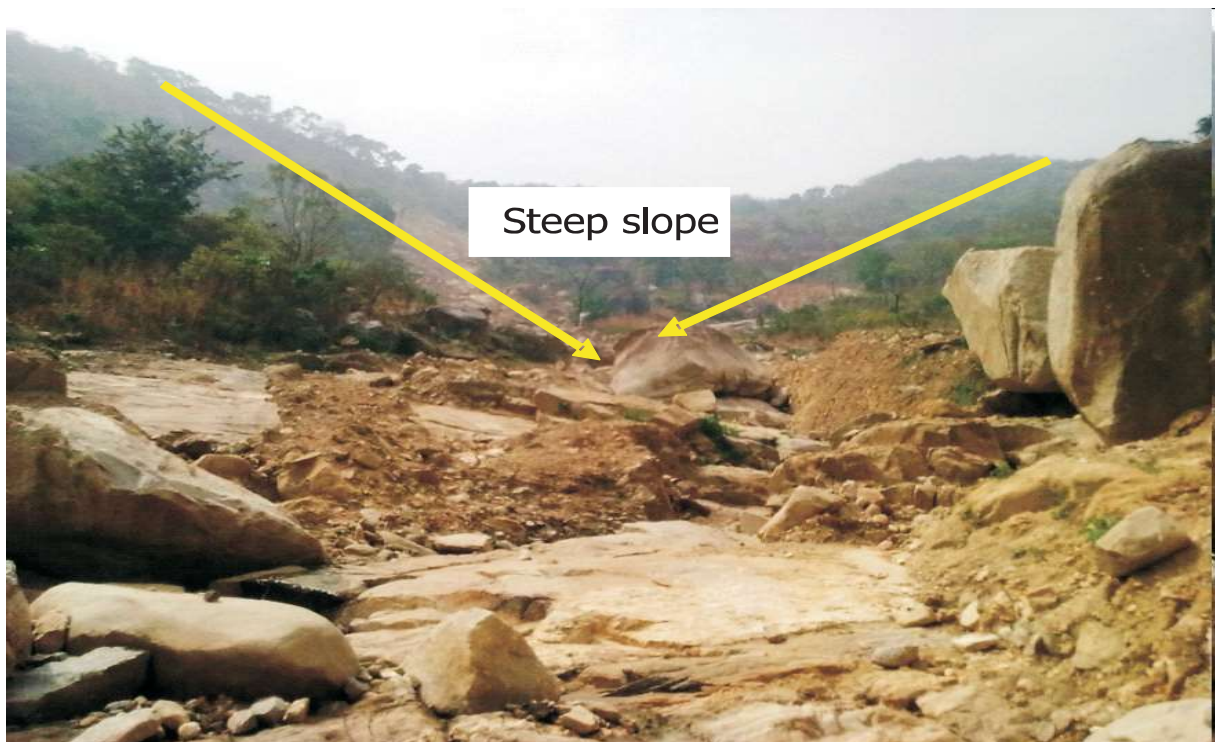
Plate 3: Photograph of steep slopes the facilitated the movement of material down slope

The rock types encountered in the area include gneisses, granites, dolerite dykes and basaltic rocks. Field evidence indicated the existence of granites, gneisses and dolerites lying unconformably on basaltic rocks. The rocks in the study area have a general strike of 240°NW with a dip of 038°NE and were highly fractured. The deep and penetrating fractures in the rocks must have brought about gradual weathering (plate 2). This resulted in slow but steady decrease in the strength of the materials, thus increasing the likelihood of sliding along slopes with gradients of 50° from the top to 5° at the toe (Plate 3).

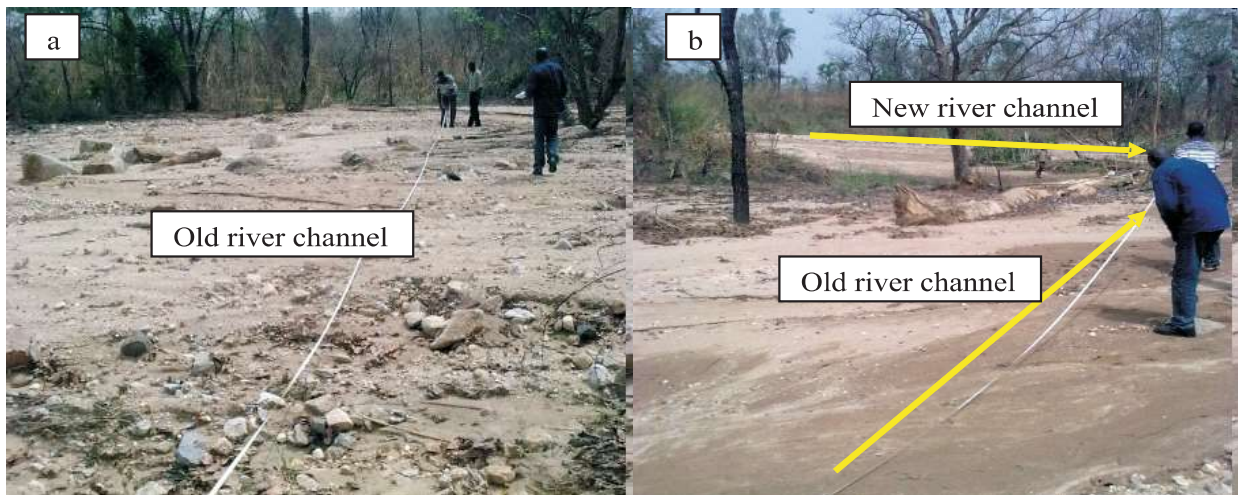
Plate 4: Photographs showing (a) materials deposited on the then river valley and (b) the development of a new river valley tangential to the old one

The materials from the slide were made up of fine debris to large fragments of the granitic and gneissic basement complex which has been intruded by dark coloured rocks believed to be volcanic rocks. The materials were deposited along the sliding path and the size of the materials decreases from the top to the bottom of the hill. The materials that were moved to the foot of the hill were deposited in the bed and flood plain of the then existing river with a width of 38.5m (plate 4a). The deposition of the materials resulted in the diversion of the river course and development of a new river tangential to the old one (plates 4b). Materials deposited were mainly small rock fragments, sand, mud and dead plant materials. The saturated soils following heavy rainfall acted as a lubricant for the materials to move rapidly and in mass down slope. The Azenge Mountain where the sliding took place has an elevation of between 950-2100m above sea level and lies along the Nigeria-Cameroon boarder with slope angles ranging from 25° at the top to 60° at the foot or toe.

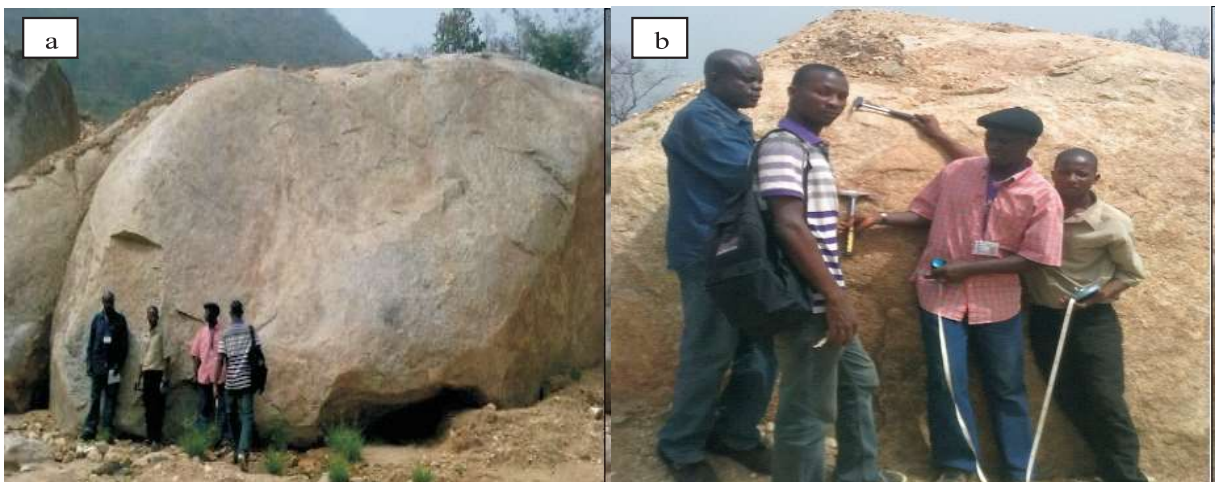
The landslide scar increased in width from the top (20m) to the base (75m) with an average depth of 58.73m and a total length of 950m. The largest boulders moved measured 15m long, 10.6m wide and 52.5m high (Plate 5a and b). The sites of the 14 slides correspond to old fault planes which have acted as conduits for the flow of water during the rainy seasons.

Plate 5: Photographs of boulders moved down slope (a) has a diameter of 71.2 m while (b) has a diameter of 88.5m. Size of materials moved decreases down the slope.

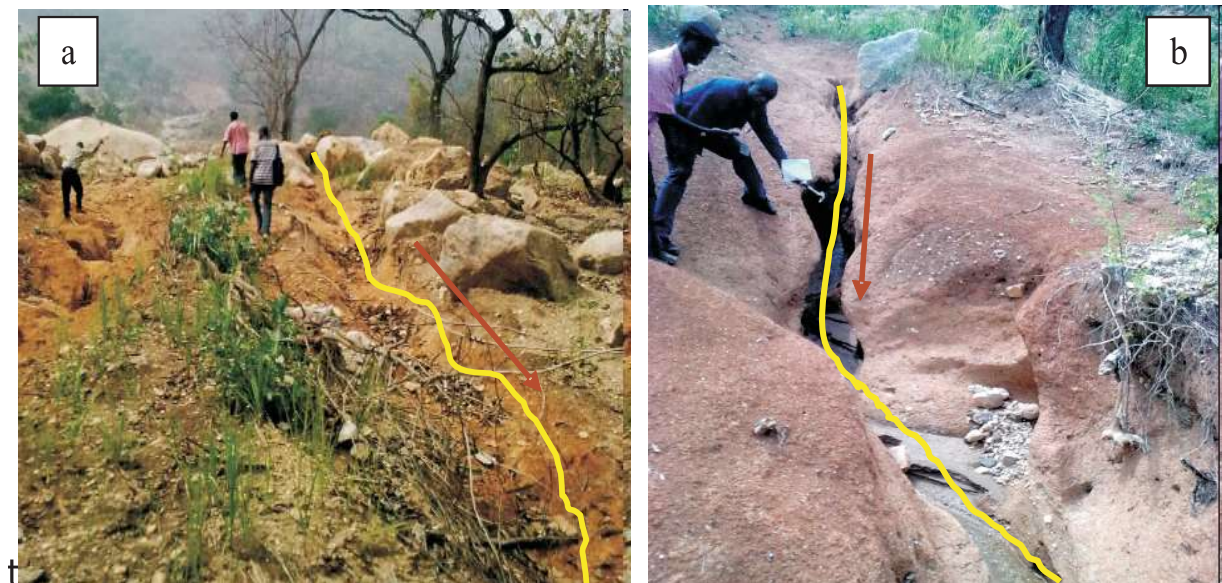
Human activities like farming and lumbering have been taking place within the area where the sliding occurred. The erosive action of the river and flood waters at the toe or foot of the hill was very visible as small and steep gullies appeared within the area where the landslide occur (plate 6a and b).

Plate 6: Photograph of gullies produced (a) at the top and (b) at the foot of the hill. Note that the depth and width of the gullies increase from the top to the foot of the hill

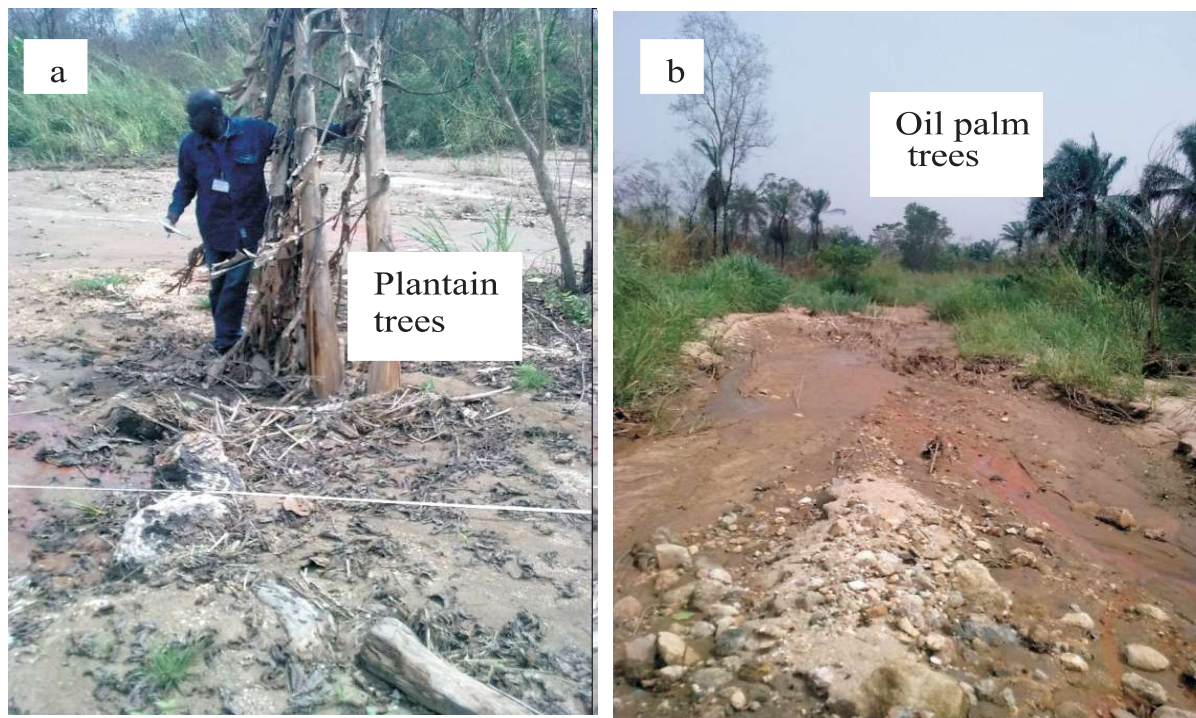
Field investigation equally showed that three rice farms, plantain and yam farms of about 200 square km and a large number of palm trees and other economic trees were destroyed (plate 7a and b).

Plate 7: Photograph of (a) plantain and (b) oil palm trees destroyed by the landslide

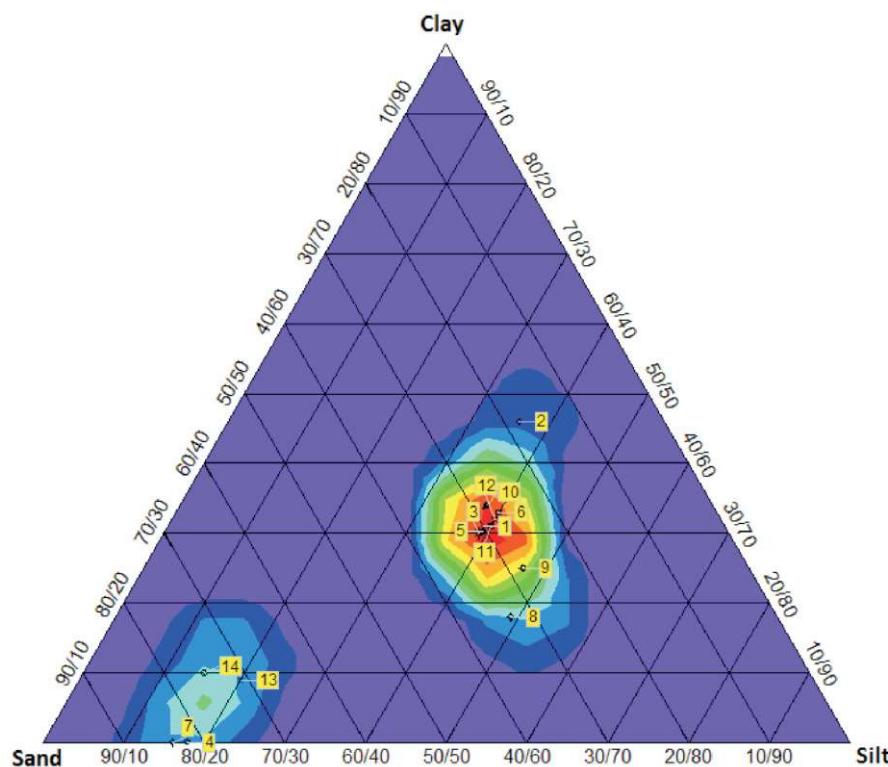
The results of sieve analysis of the fourteen soil samples collected from the landslides site is presented in table 1 and plotted figures 3. These show that the soil display a wide range of grain sizes including clay, silt and sand fractions. However, most of the samples (1,2,3,5,6,7,8,9,10,11, and 12) are composed of mainly clay sized particles (Ttable 1). They are interpreted as soils of grain sizes that are mostly susceptible to sliding. These soils combined with water act as lubricant. A plot of these samples on the grain size triangle (Fig.3) reflects soil with very high degree of susceptibility to sliding above the sliding surface. However, four samples (i.e. 4, 7, 13, and 14) that were collected below the sliding and away from the sliding surfaces are mostly made up of sand and are less susceptible from sliding and plot outside the failure zone. These samples tend to be predominant of one grain size fraction that tends to cause instability within the unit (Fig. 3).

Figure 3: Plots of results of grain size analysis showing two groups of soils based on their susceptibility to sliding (modified from Ayonghe and Ntasin, 2008).

Ayonghe and Ntasin (2008), Telerico et al. (2004) and Howard et al. (1988) carried out similar studies of soil from landslides and used the results to establish the range of soil grain sizes that are most susceptible to sliding and established that soils containing large amount of sand or gravel are less susceptible since their components have a stabilizing influence on the soil mass.
